# STAFFORDVILLE RESERVOIR DAM CT. 00333

## PHASE I INSPECTION REPORT NATIONAL DAM INSPECTION PROGRAM

DECEMBER 1978

Identification Number:	CT 00333
Name:	Staffordville Reservoir Dam
Town:	Staffordville
County and State:	Tolland County, Connecticut
Stream:	Furnace Brook
Date of Inspection:	October 5, 1978

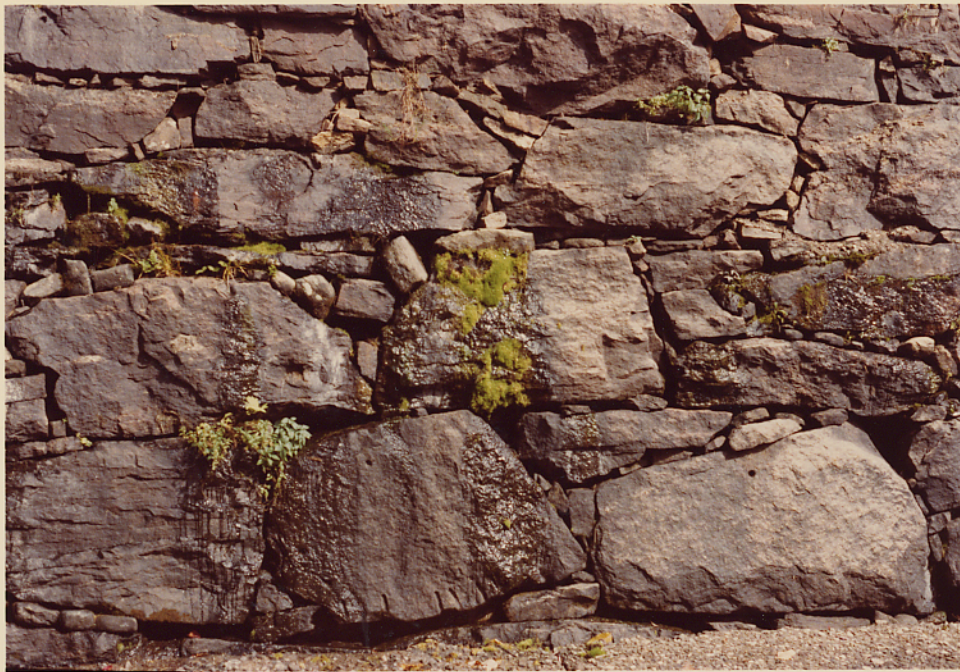
c. Visual Observations - The spillway at the time of the inspection was in good condition with some evidence of water seeping through the face of the dam (Appendix C, Photo 5).

PHOTO 5  
SEEPAGE THROUGH STONE MASONRY WALL

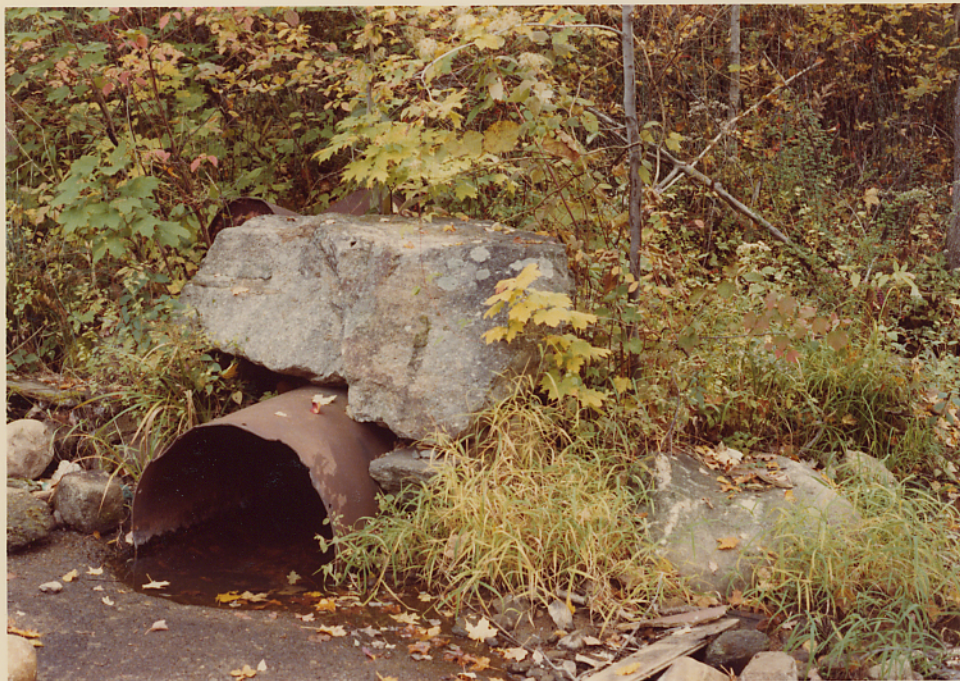
The 30 inch blowoff is in fair condition and appears to be operable.

PHOTO 6  
BLOWOFF OUTLET

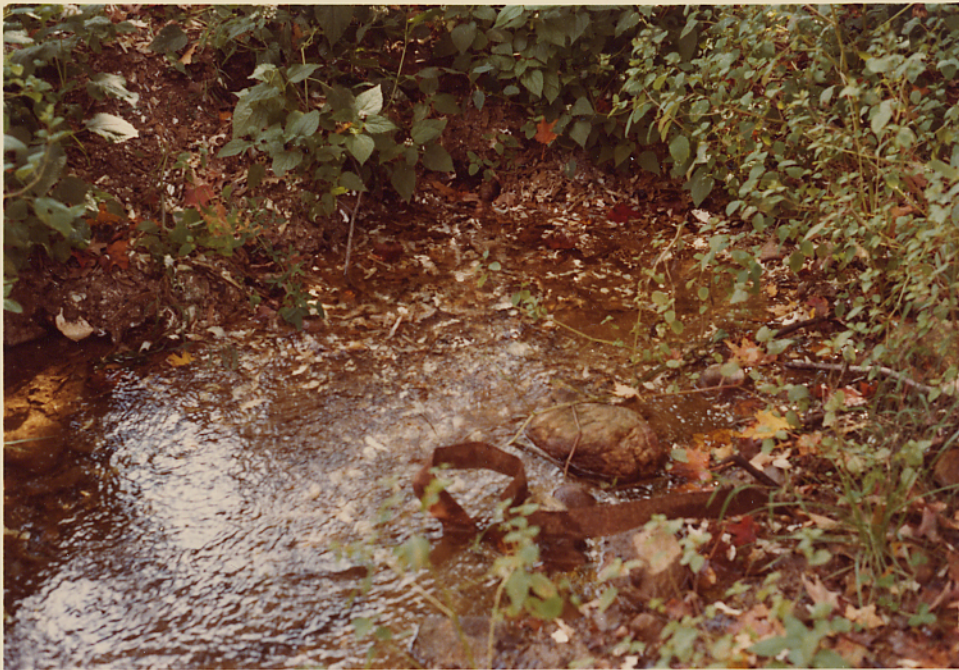
The east bank of the downstream side of the dam shows a significant amount of water flowing from the ground that appears to be caused from a broken pipe in the lower gate chamber. This condition should be investigated further, because it could be a potentially dangerous condition.

PHOTO 7  
ACTIVE BOIL BELOW GATE HOUSE

In view of the lack of routine maintenance procedures, it is suggested that written procedures be established. There has been no recent effort made to clean-up the downstream area or to repair damage to the body of the dam itself. It is very important to make sure that the broken pipe inside the lower gate chamber is repaired. This should at least help the potentially dangerous boil that exists in this area.

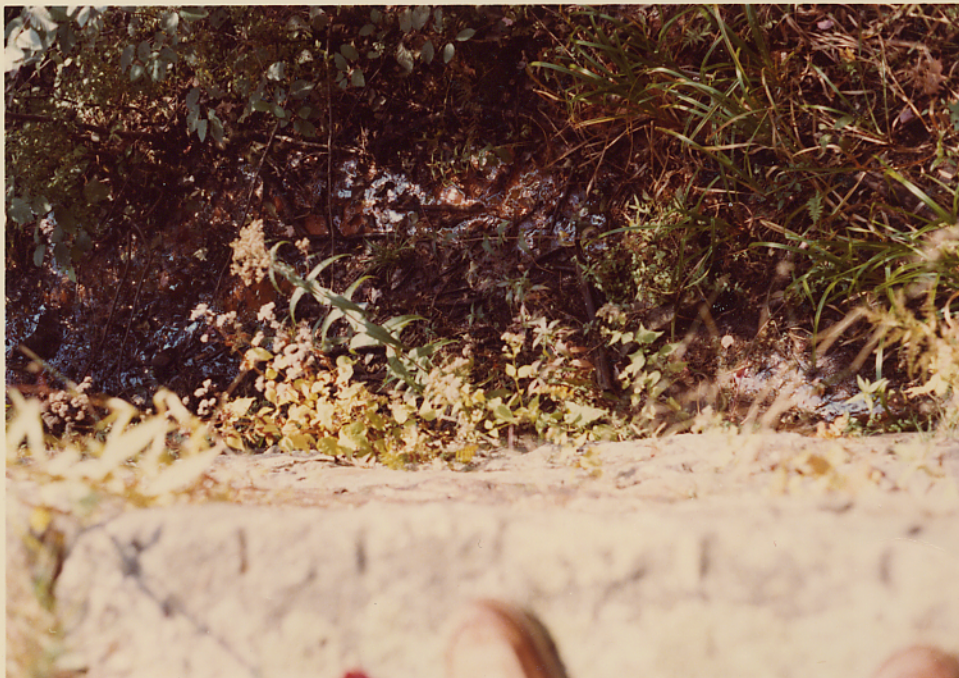
in the mortared joints of the concrete masonry. The observation of the extensive zone of seepage on the west side, the flowing water on the east side and the broken pipe in the gate chamber indicates a need for further study so that the extent of this problem can be defined.

PHOTO 8  
SEEPAGE AREA AT WEST TOE
